NPDES INSPECTION REPORT

CITY OF ABERDEEN, ID WASTEWATER TREATMENT FACILITY

March 12, 2012

Prepared by:
David Domingo
NPDES Compliance Unit
Office of Compliance and Enforcement
Environmental Protection Agency, Region 10

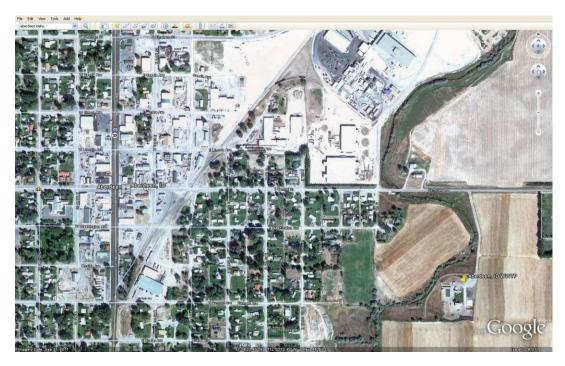
Aerial photograph of the City of Aberdeen, ID wastewater treatment plant. Facility is located on the east side of the city and discharges effluent to the Aberdeen Drain which flows into American Reservoir.

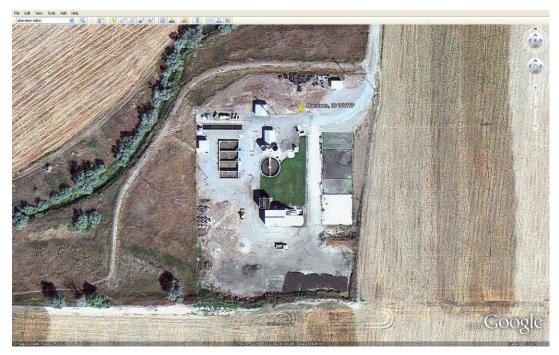
Aerial photograph of the City of Aberdeen, ID wastewater treatment plant. Facility is located on the east side of the city and discharges effluent to the Aberdeen Drain which flows into American Reservoir.

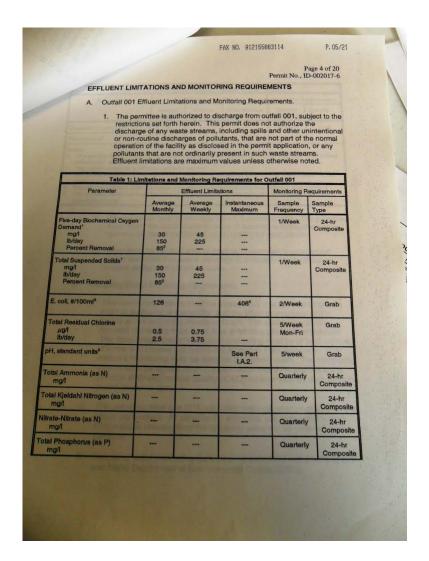
Photograph by David Domingo (EPA) on March 12, 2012 looking at Table 1 of the final permit. Note the sample frequency for E. coli is two times per week and fecal coliform monitoring is not required.

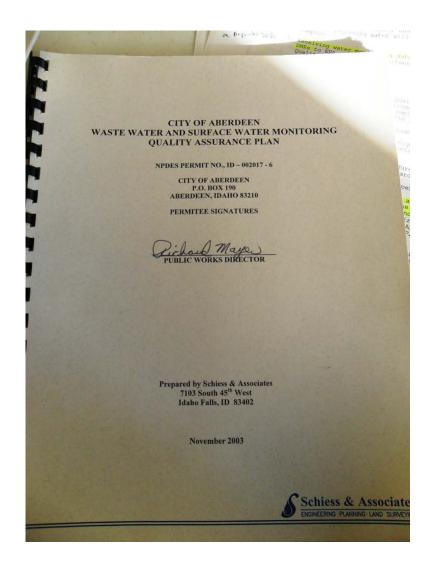
Photograph by David Domingo (EPA) on March 12, 2012 looking at the QAP for the Facility.

Photograph by David Domingo (EPA) on March 12, 2012 looking at Table 3 of the QAP. Note the sample preservation temperatures are not consistent with the most recent EPA approved methods (i.e. \leq 6° for BOD, TSS... or \leq 10°C for E. coli). Also, the correct EPA approved method, detection limit and holding time for E. coli are EPA 1103.1, 1 CFU / 100 ml and 6 hours, respectively. Sample preservation must include pH < 2 in addition to H_2SO_4 .

- a. Sample preservation temperatures are not consistent with the most recent EPA approved methods (i.e. \leq 6°C for BOD, TSS, NH₃... or \leq 10°C for E. coli but not frozen).
- b. The correct EPA approved method, detection limit and holding time for E. coli were not identified (i.e. EPA 1103.1, 1 CFU / 100 ml and 6 hours).
- c. Sample preservation must include pH < 2 in addition to H_2SO_4 for NH_3 , TP, $NO_3...$
- d. The correct EPA approved method detection limit for dissolved oxygen was not identified (i.e. 0.1 mg/l for membrane electrode method).
- e. Protocols for sampling techniques for onsite analysis of pH, TRC, temperature and dissolved oxygen were not included.

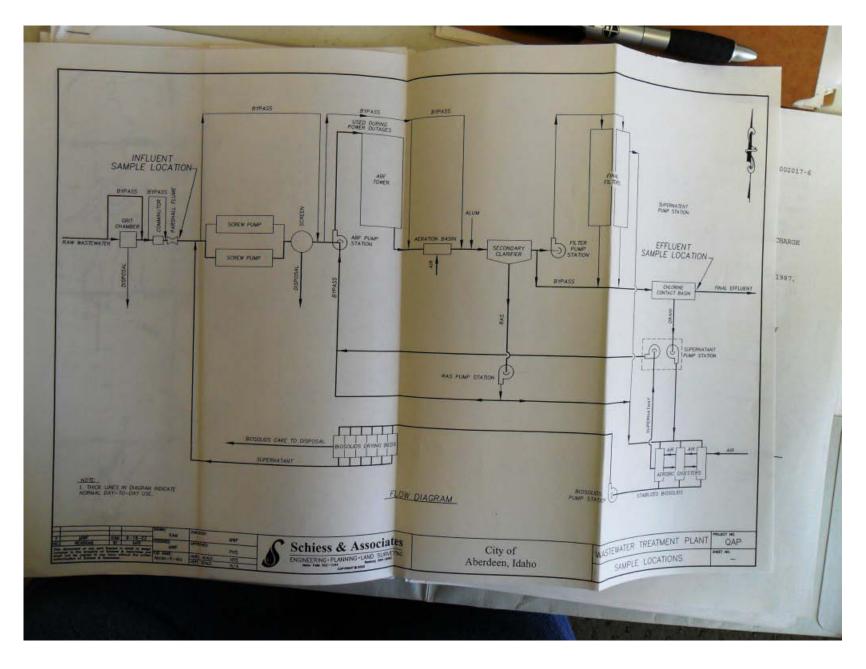
Photograph by David Domingo (EPA) on March 12, 2012 looking at the process flow diagram which indicates the influent and effluent monitoring locations at the Facility.

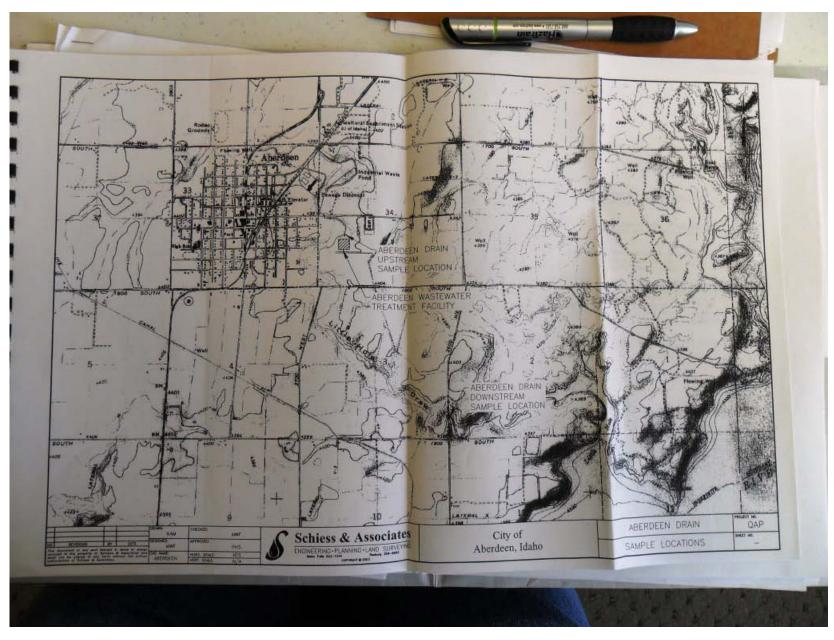
Photograph by David Domingo (EPA) on March 12, 2012 looking at the map indicating the receiving water monitoring locations.

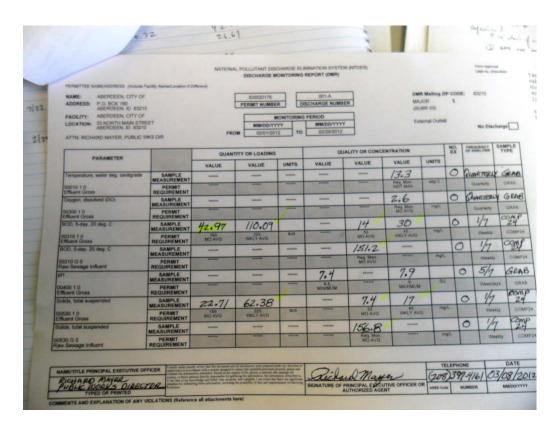
Photograph by David Domingo (EPA) on March 12, 2012 looking at the February 2012 DMR. Note the City used the average monthly flow of 0.368 mgd to calculate the average monthly loadings for BOD and TSS instead of using the corresponding flow on the day sampling occurred.

- a. Monthly average BOD and TSS loadings were calculated using the average monthly flow instead of the corresponding flow on the days sampling occurred.

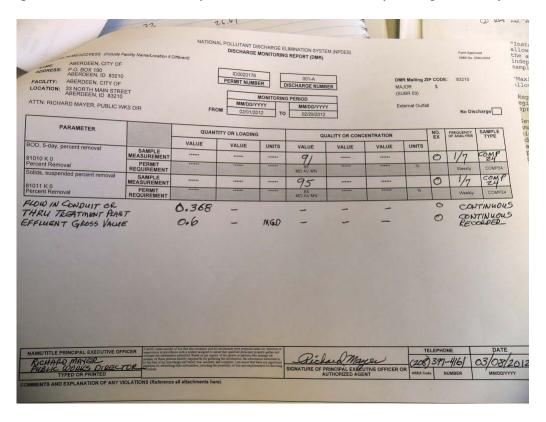
Photograph by David Domingo (EPA) on March 12, 2012 looking at the February 2012 DMR. Note the City reports flow on the DMR. According to Mr. Mayer, the City reported average monthly flow (i.e. 0.368 mgd) and maximum daily flow (i.e. 0.6 mgd).

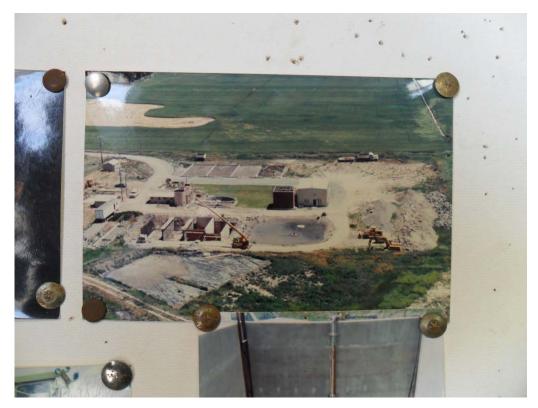
Photograph by David Domingo (EPA) on March 12, 2012 looking at a photo of construction during the last facility upgrade in 1991. The photo is located at the current Facility.

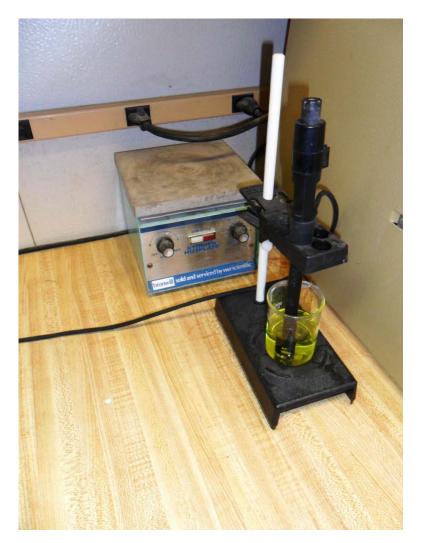
Photograph by David Domingo (EPA) on March 12, 2012 looking at the probe for the pH meter.

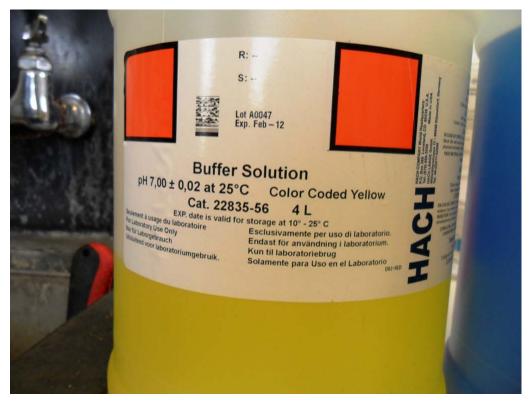
Photograph by David Domingo (EPA) on March 12, 2012 looking at the pH 7.0 buffer used to calibrate the meter. Note the expiration date of February 2012.

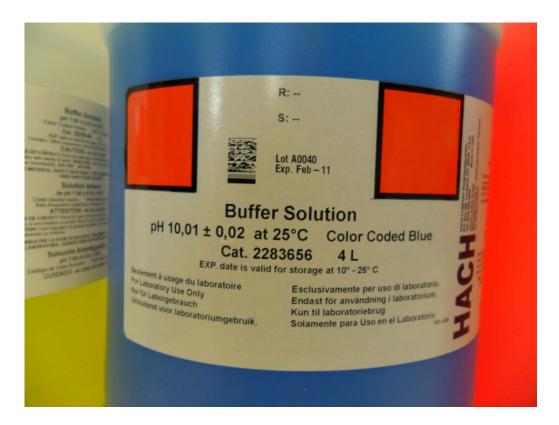
Photograph by David Domingo (EPA) on March 12, 2012 looking at the pH 10.0 buffer used to calibrate the meter. Note the expiration date of February 2011.

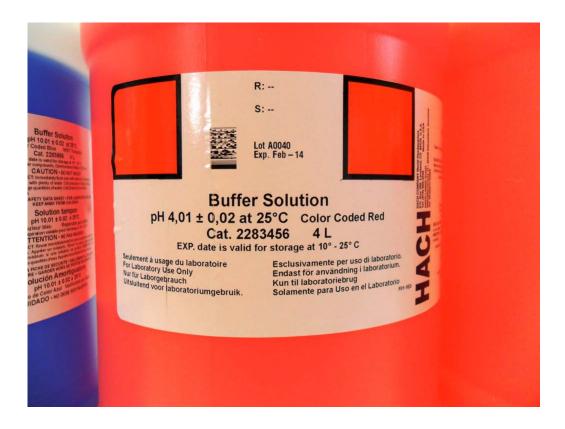
Photograph by David Domingo (EPA) on March 12, 2012 looking at the pH 4.0 buffer used to calibrate the meter. Note the lot number A0040 and expiration date of February 2014.

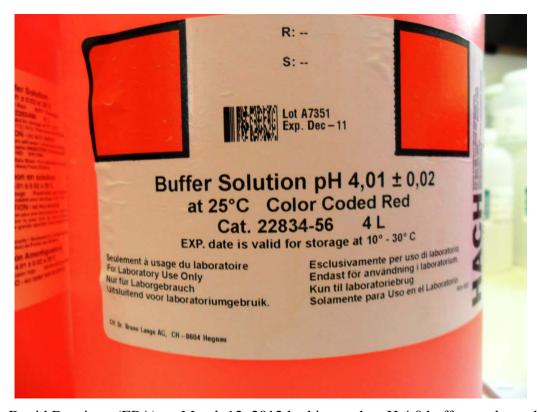
Photograph by David Domingo (EPA) on March 12, 2012 looking at the pH 4.0 buffer used to calibrate the meter. Note the lot number A7351 and expiration date of December 2011.

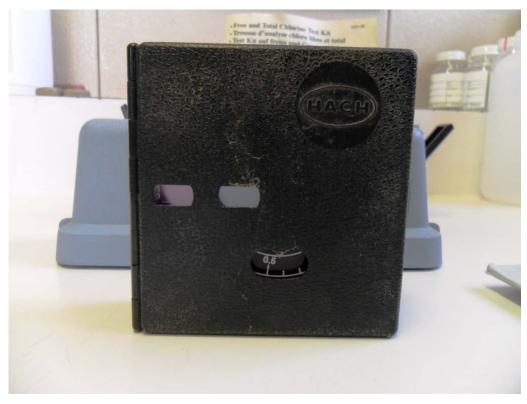
Photograph by David Domingo (EPA) on March 12, 2012 looking at the total residual chlorine (TRC) meter for the Facility.

- B. <u>Representative Sampling</u> Part III.A of the Permit specifies samples and measurements must be representative of the volume and nature of the discharge. At the time of the inspection, I noted that total residual chlorine meter currently used at the Facility may not provide a representative measurement.

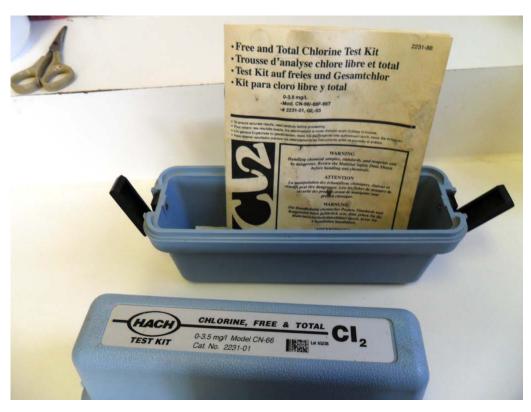
Photograph by David Domingo (EPA) on March 12, 2012 looking at the total residual chlorine (TRC) meter for the Facility.

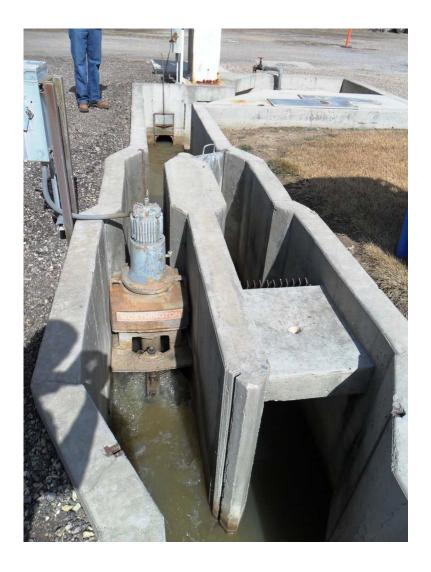
Photograph by David Domingo (EPA) on March 12, 2012 looking at wastewater as it enters the Facility. Influent passes through the comminutor and then to the influent flow and sampling location. According to Mr. Mayer, flow can be diverted around the comminutor through the manual bar screen if necessary.

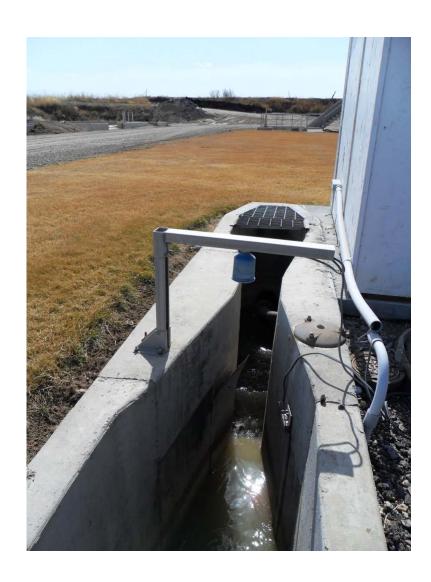
Photograph by David Domingo (EPA) on March 12, 2012 looking south at the influent flow and sampling location. Wastewater flows from the comminutor through this location to the screw pumps located in the background (top of photo).

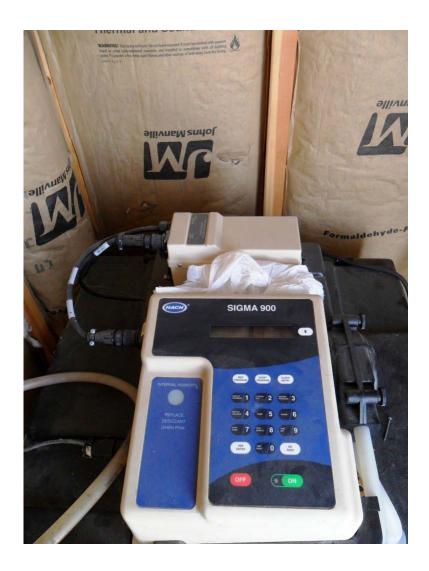
Photograph by David Domingo (EPA) on March 12, 2012 looking at the Sigma 900 composite influent sampler. According to Mr. Mayer, the sampler is programmed to take \sim 100-150 ml every hour.

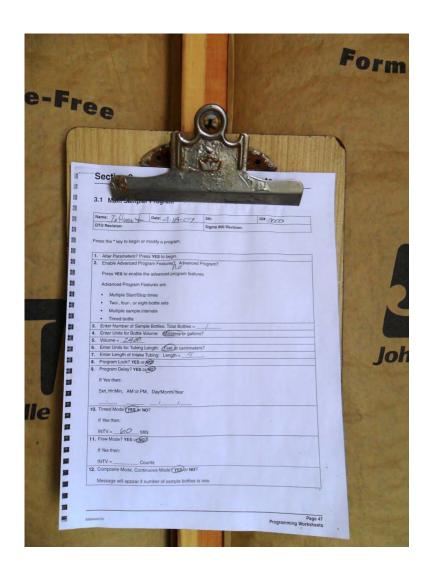
Photograph by David Domingo (EPA) on March 12, 2012 looking at the recording sheet for the influent sampler. Note the sheet does not identify the sample preservation temperature.

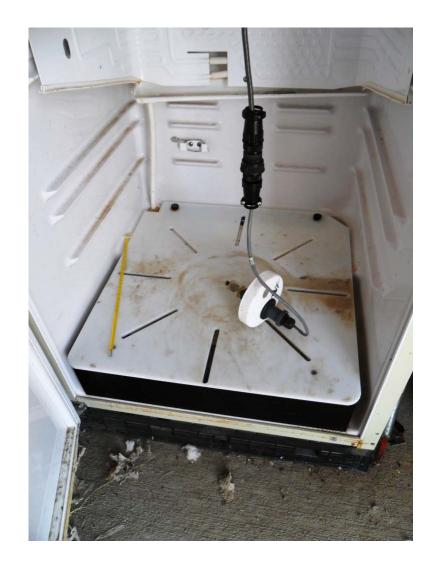
Photograph by David Domingo (EPA) on March 12, 2012 looking at the influent sampler. According to Mr. Mayer, the samplers are refrigerator during collection and the temperature is monitored using the thermometer.

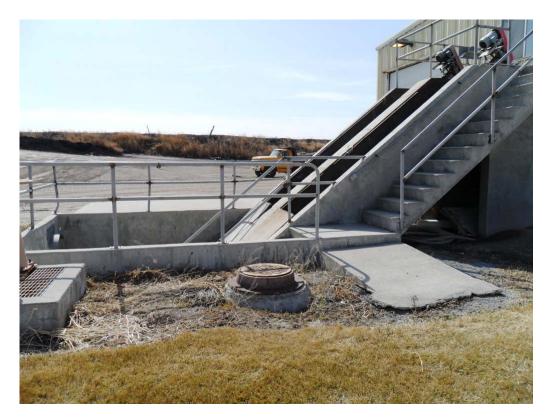
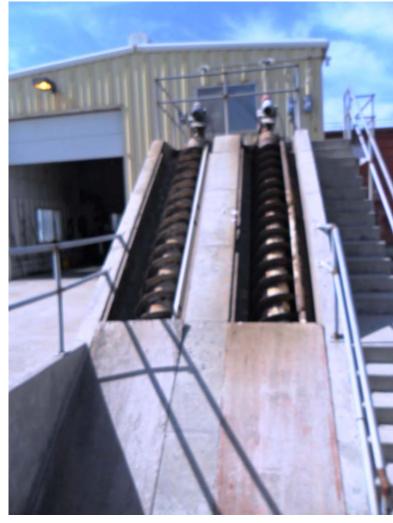
Photograph by David Domingo (EPA) on March 12, 2012 looking south at the two screw pumps. Wastewater flows from this unit to the fine screen.

Photograph by David Domingo (EPA) on March 12, 2012 looking at the two screw pumps. Wastewater flows from this unit to the fine screen.

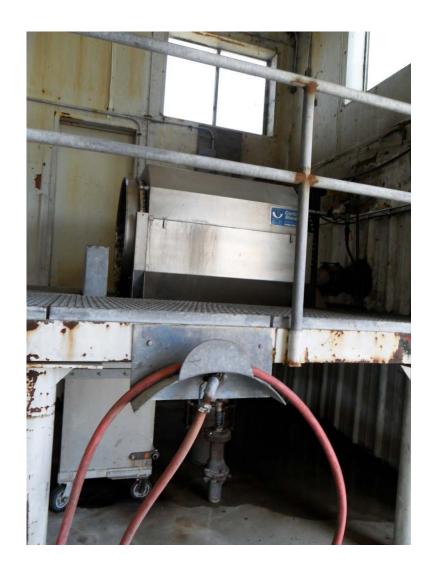
Photograph by David Domingo (EPA) on March 12, 2012 looking at the fine screen. Solids from the unit are handled by the county and disposed of with the municipal solid waste. Wastewater flows from the screen to the wet well inside the building and then pumped to the ABF tower.

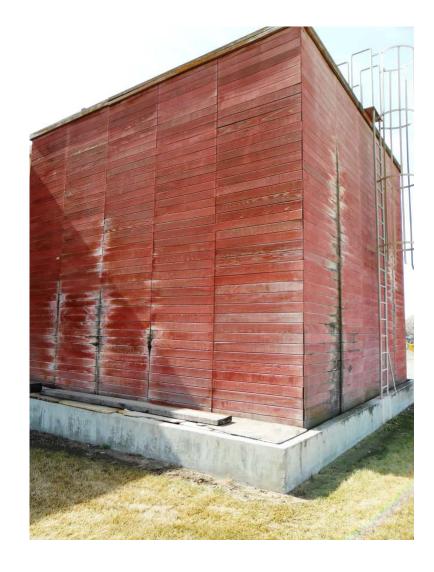
Photograph by David Domingo (EPA) on March 12, 2012 looking at the ABF tower. Wastewater flows from the tower to the same wet well located inside the adjacent building.

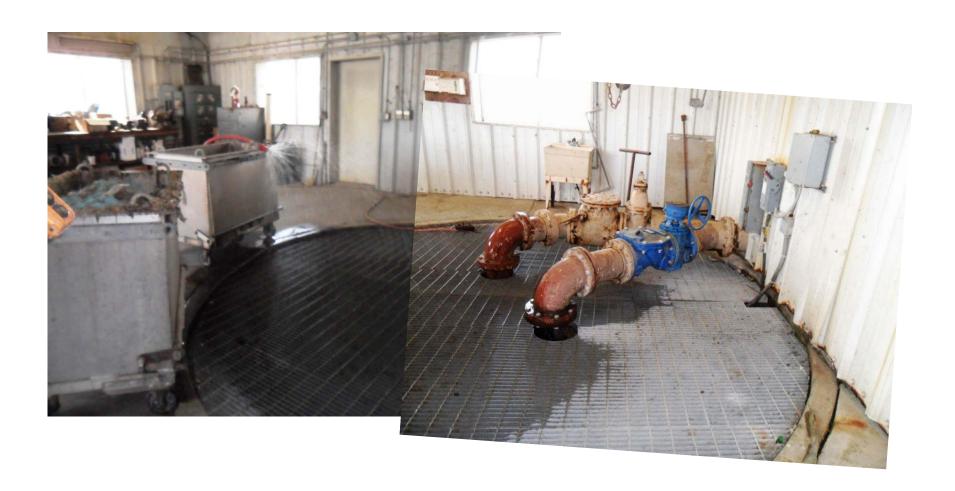
Photograph by David Domingo (EPA) on March 12, 2012 looking at the wet well. Wastewater flows from the screen to the wet well and then pumped to the top of the ABF tower. Wastewater from the ABF tower returns to a different compartment of the wet well where it is pumped to the aeration basins. According to Mr. Mayer, during high flows the wastewater from the ABF tower may exceed the capacity of the applicable compartment inside the wet well and mix with the wastewater being pumped to the top of the ABF tower.

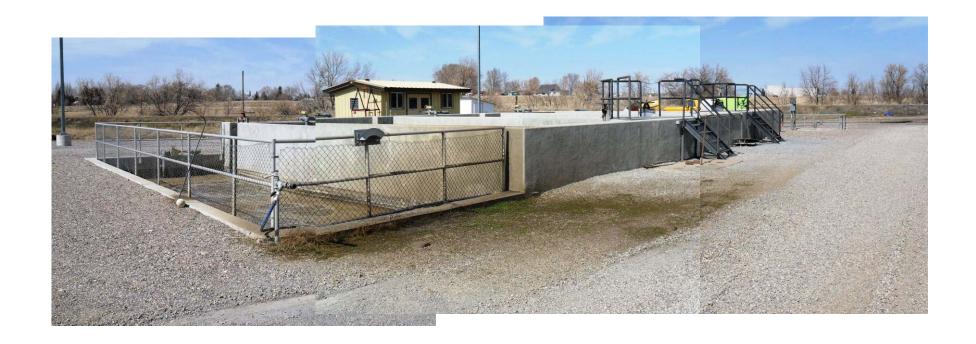
Photograph by David Domingo (EPA) on March 12, 2012 looking west to north at the aeration basins. Wastewater flows from these basins to the secondary clarifier.

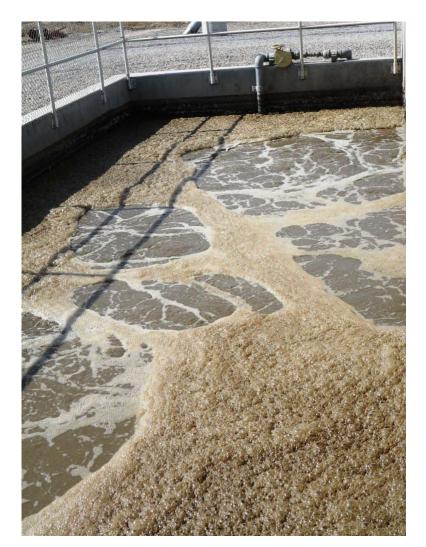
Photograph by David Domingo (EPA) on March 12, 2012 looking at one of the aeration basins. Wastewater flows from the basins to the secondary clarifier.

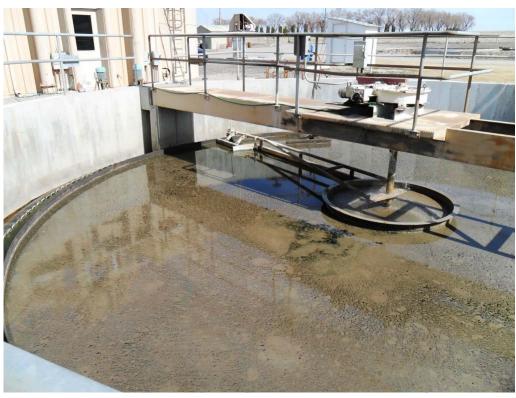
Photograph by David Domingo (EPA) on March 12, 2012 looking at the secondary clarifier. Wastewater flows from the clarifier to the chlorine contact basin.

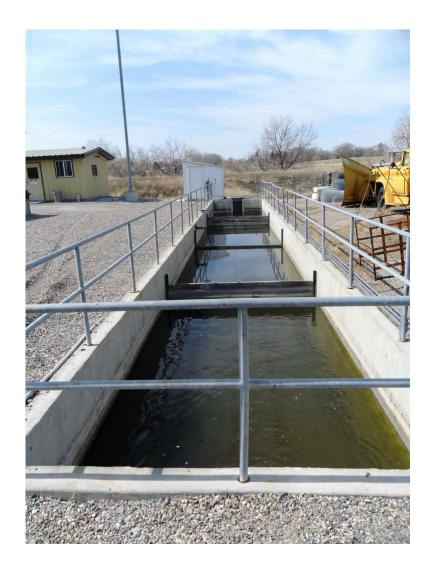
Photograph by David Domingo (EPA) on March 12, 2012 looking west at the chlorine contact basin. Wastewater flows from the basin to outfall 001. Effluent flow and sampling occur at the west end of the basin.

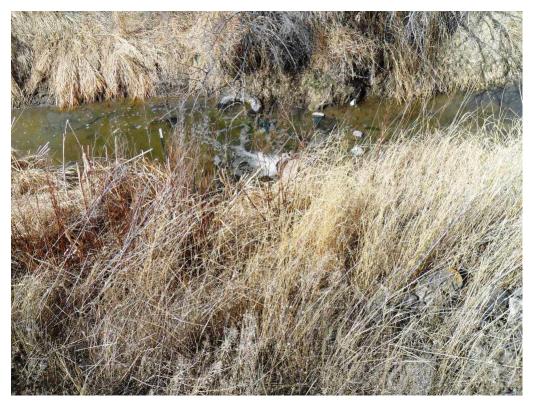
Photograph by David Domingo (EPA) on March 12, 2012 looking at outfall 001. Wastewater flows from the chlorine contact basin and discharges to Aberdeen Drain through outfall 001.

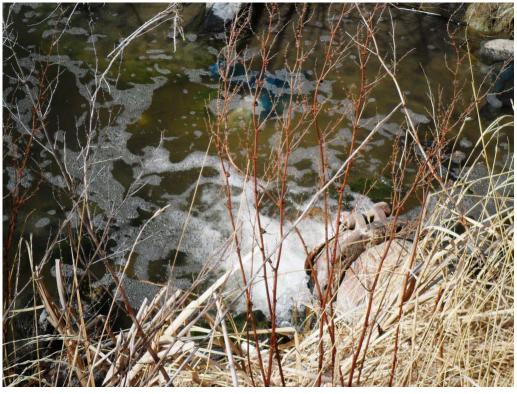
Photograph by David Domingo (EPA) on March 12, 2012 looking at outfall 001. Wastewater flows from the chlorine contact basin and discharges to Aberdeen Drain through outfall 001.

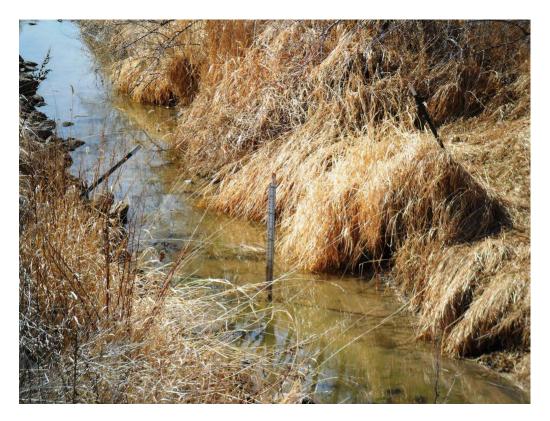
Photograph by David Domingo (EPA) on March 12, 2012 looking at the staff gauge within Aberdeen drain downstream of outfall 001. According to Mr. Mayer, the gauge is used to measure flow within the drain.

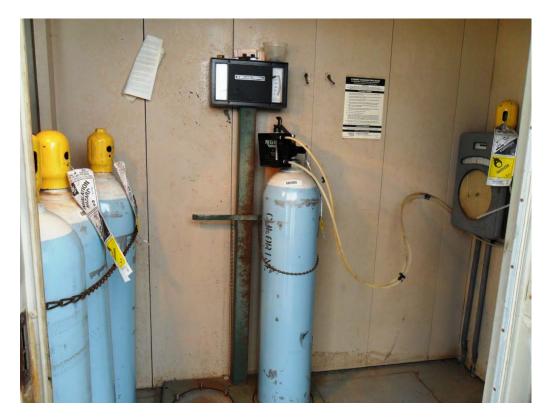
Photograph by David Domingo (EPA) on March 12, 2012 looking at the 150 lb chlorine gas cylinders used to disinfect the wastewater. The gas is mixed with water and injected prior to the chlorine contact basin.

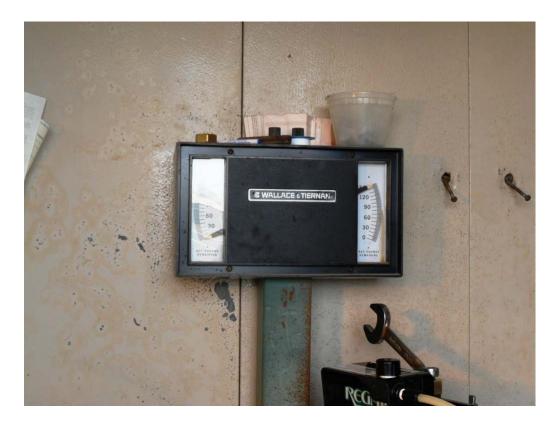
Photograph by David Domingo (EPA) on March 12, 2012 looking at the scale used to monitor the 150 lb chlorine gas cylinder currently in use.

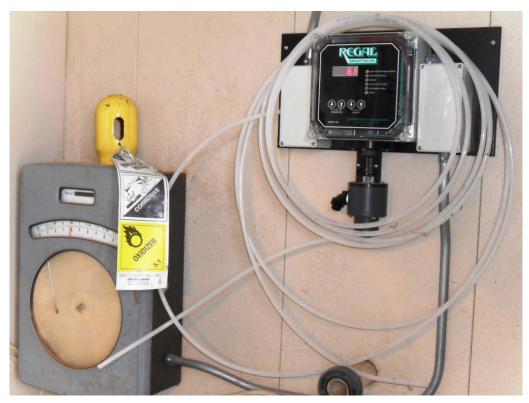
Photograph by David Domingo (EPA) on March 12, 2012 looking at the 150 lb chlorine gas cylinders used to disinfect the wastewater. The gas is mixed with water and injected prior to the chlorine contact basin.

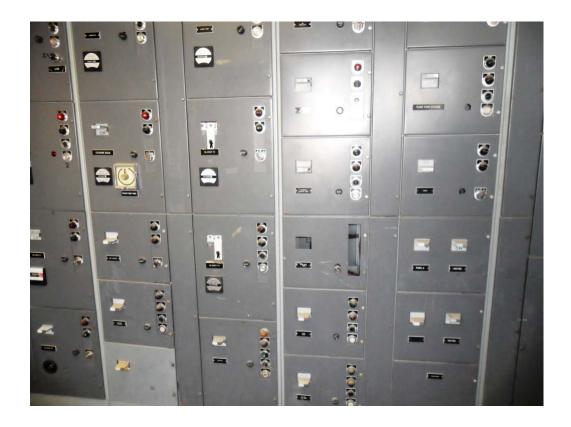
Photograph by David Domingo (EPA) on March 12, 2012 looking at the control panel for the Facility.
